Job #3097931

Masonry Thimble Chimney Serving Appliance

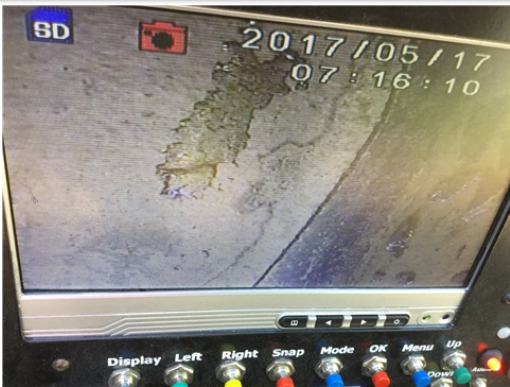
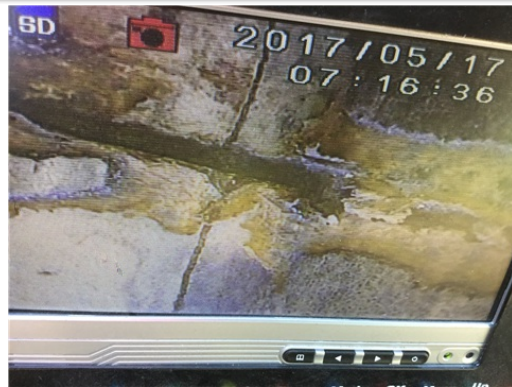
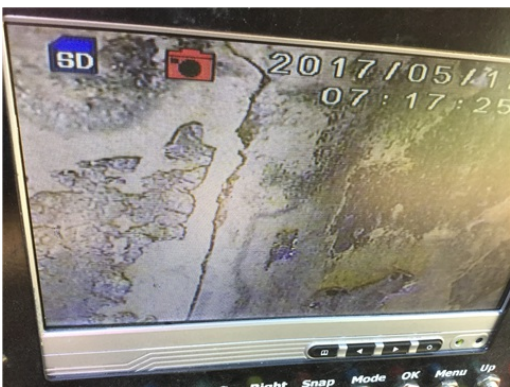
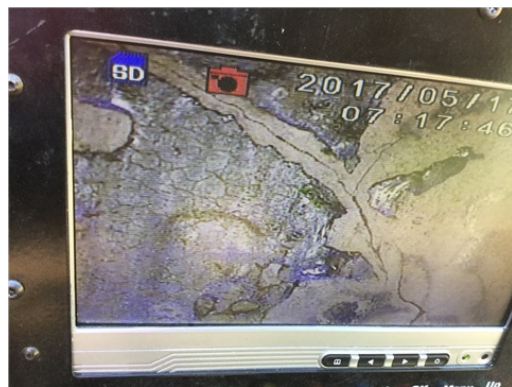
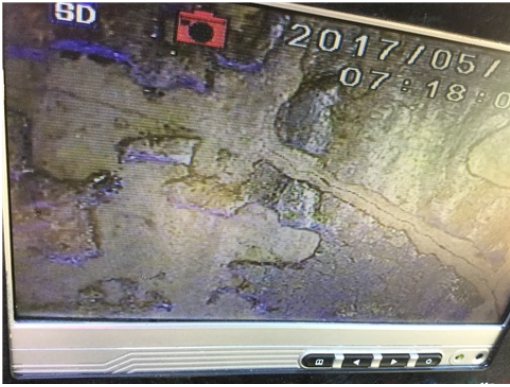
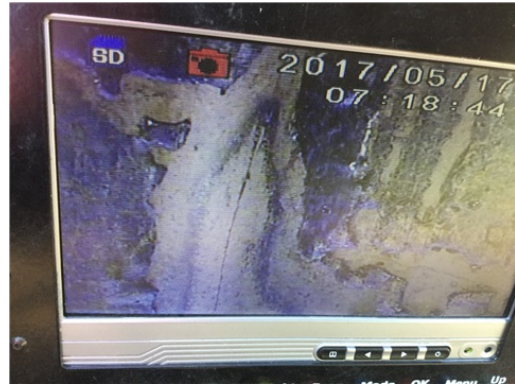
4B

Does the flue lining have any defects?

"Upon arrival noticed in top portion of flue tiles that heavy 3rd degree glaze creosote had obviously caught fire and expanded all curled up and puffy balls of expanded creosote. After a full camera inspection of the flue tiles after cleaning found that indeed there was a sudden occurrence of a chimney fire in the flue tiles towards the upper 1/3. 4 of the flue tiles has cracked vertically top to bottom. Evidence of air being sucked into the cracks causing it to burn even hotter. Due to the damage the flue tile will need to be replaced with a stainless steel liner system"

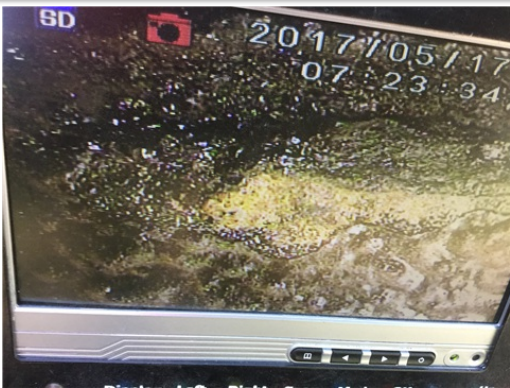
"Several of the mortar joints have crumbled from expansion of the flue tiles due to the chimney fire"

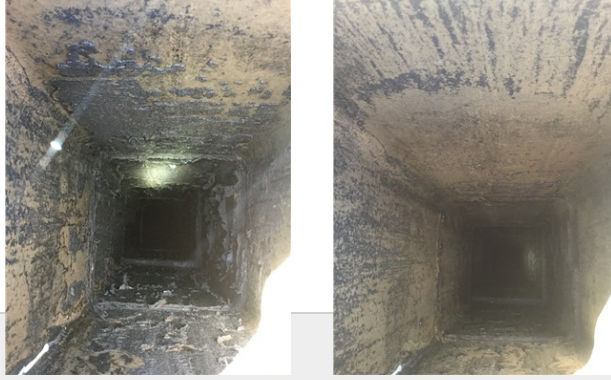
Yes
"Before and after cleaning, note how clean it is at the top where it burned off extremely hot"

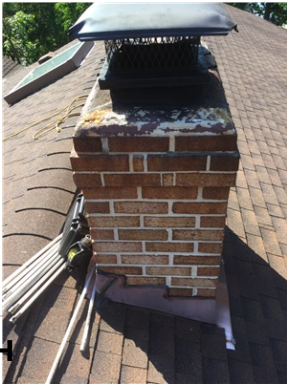
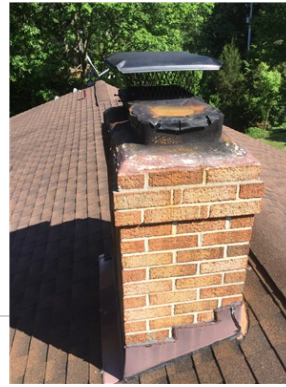
"The top crown has cracked from tile expansion"

"The crown has split in different areas from expansion of the flue tiles. It will need to be replaced"

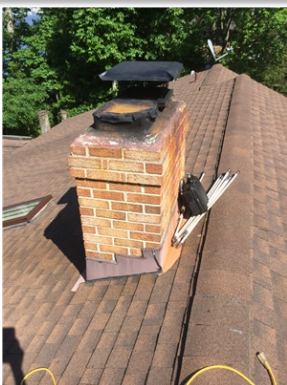
Yes, and this is a potential water problem, this chimney should have a small diverter roof to shed water and debris away from the chimney. See 2015 IRC section R1003.20

"Unfortunately it is too close to the peak for a cricket"
