Job #4996618

## Masonry Fireplace 1

123 Fake Street, La Plata, MD 20646 USA

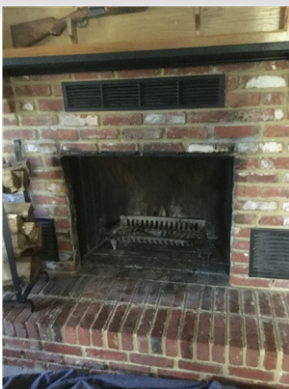
1

Picture of appliance from across the room.

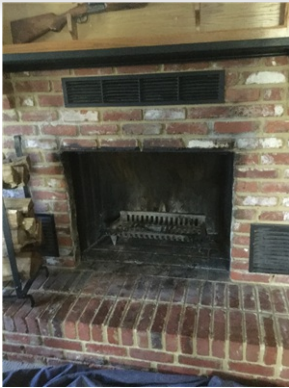
**4A**

What is the fireplace faced with?

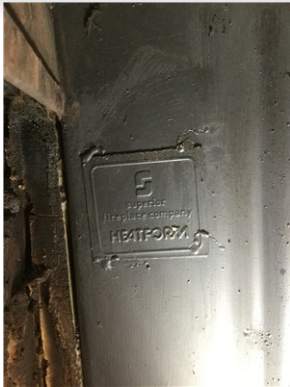
**4B**

☒ Heatform with tubes

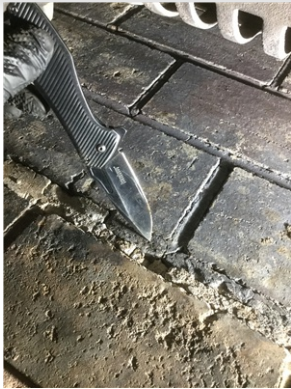
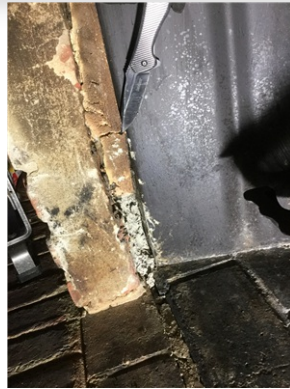
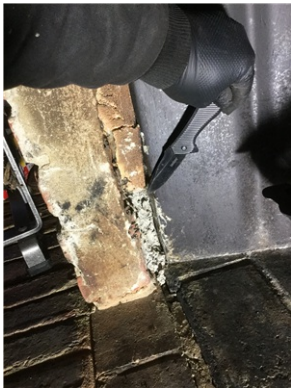
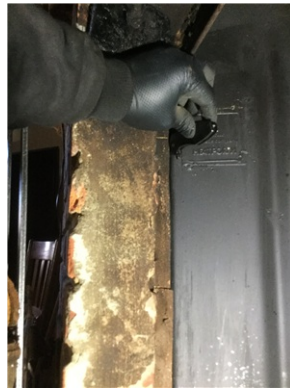
**4E**

☒ No, This should be tightly sealed to the firebox opening. Not being sealed will allow heat and combustion byproducts to escape the system. This needs to be sealed up before the fireplace is used again.

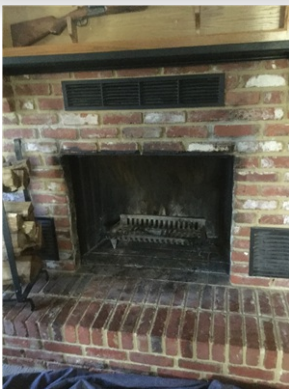
**4F**

Firebox

- ☒ Deteriorated/ missing mortar joints: From either fatigue or water entry. Firebox should be rebuilt before use of the appliance.

"Entire joint around heatform needs to be replaced, firebox transition joint into hearth extension needs to be replaced."

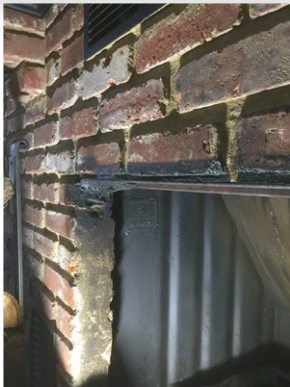
**4J**

- ☒ Yes: Smoke stains in this area indicate that the fireplace is not performing properly and allowing the by-products of combustion to enter the home. This area should be completely clean.

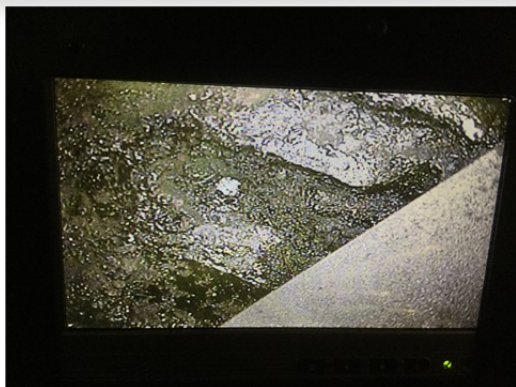
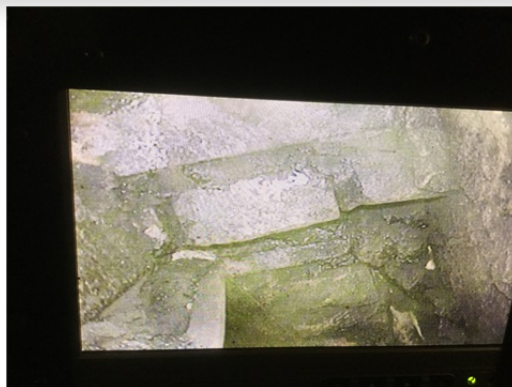
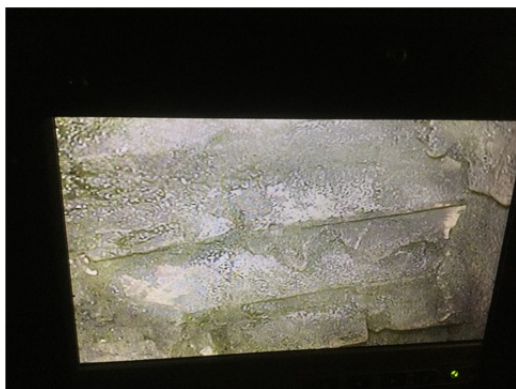
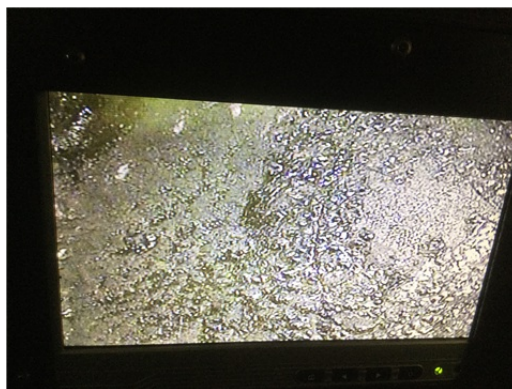
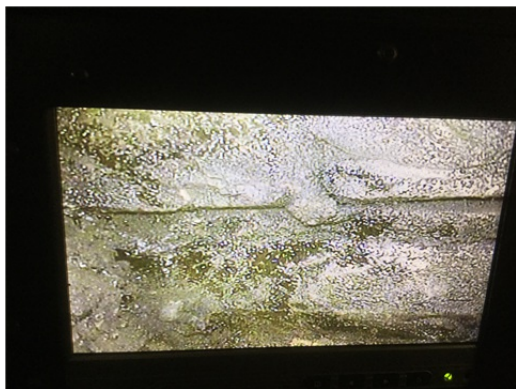
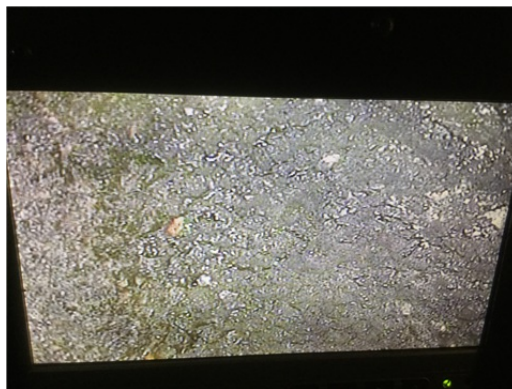
- ☒ Well Filled: Brick corbels are exposed and collecting creosote in these area. They need to be thoroughly cleaned with chemicals and filled in with a refractory mortar.
-

☒ No, this area should be completely smooth and parged over with refractory mortar. This area serves as a funnel for the flue to convey the by products of combustion up into the flue lining. The extra turbulence in the smoke chamber will cause increased heat transfer and poor draft. If left untreated this can lead to unwanted heat transfer that could potentially result in an unwanted fire. See 2015 IRC R1001.8 & 2016 NFPA 211 Section 11.2.1.13

☒ Glazed Creosote is present and highly flammable. This should be removed before use of the appliance.

☒ No, This is not properly sealed and allows smoke to go around to the outside of the tile  
☒ Not properly supported on all four sides.

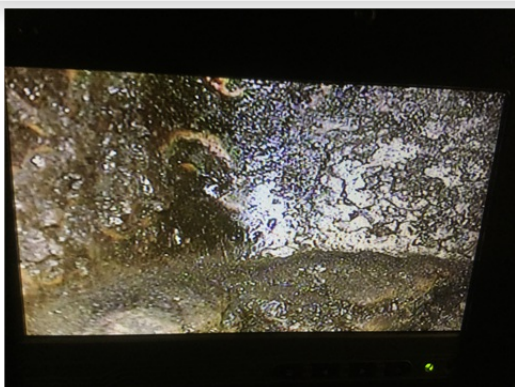
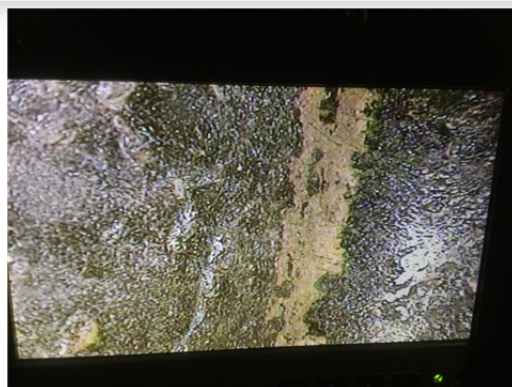
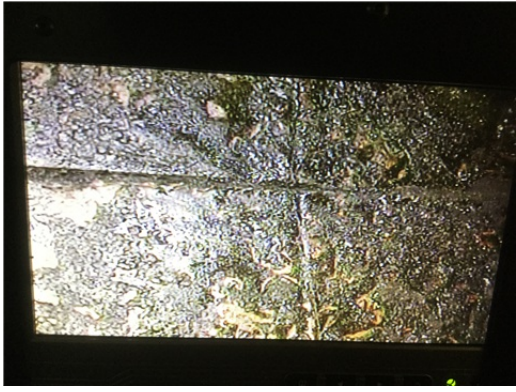
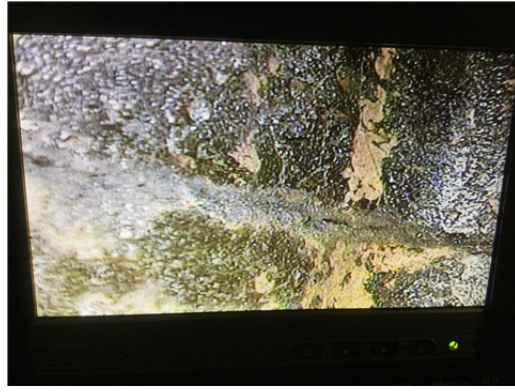
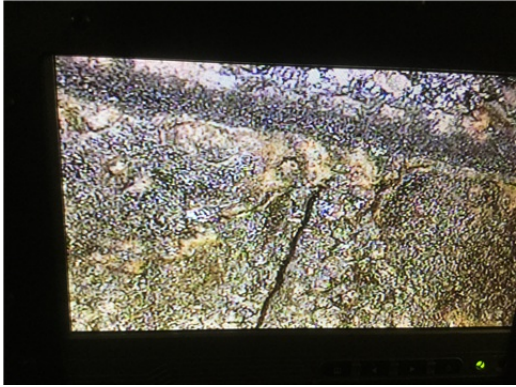
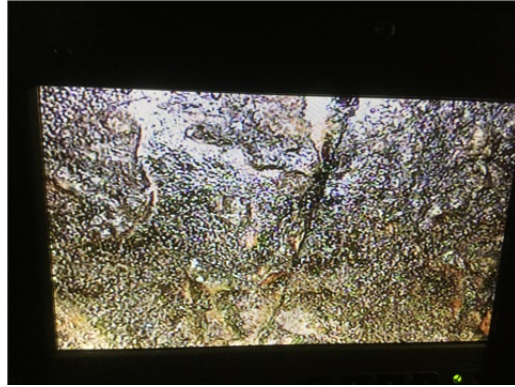
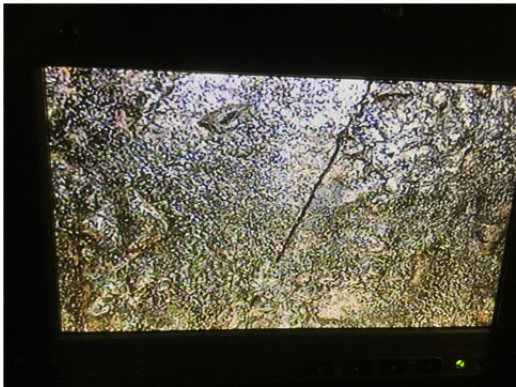
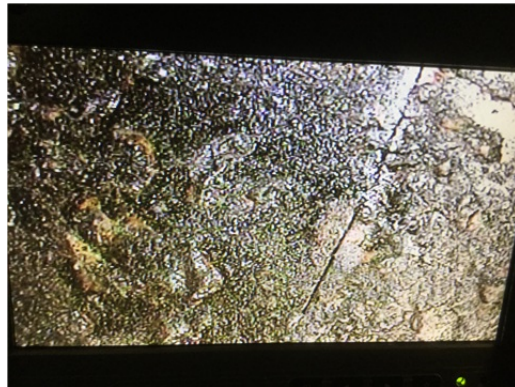
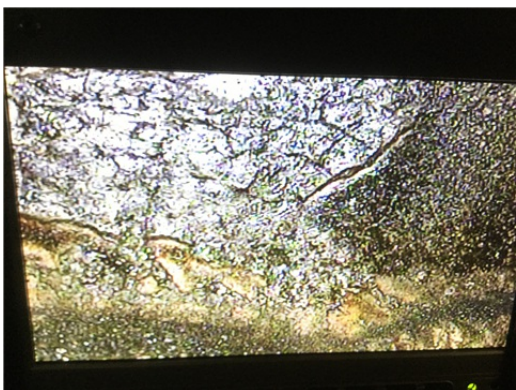
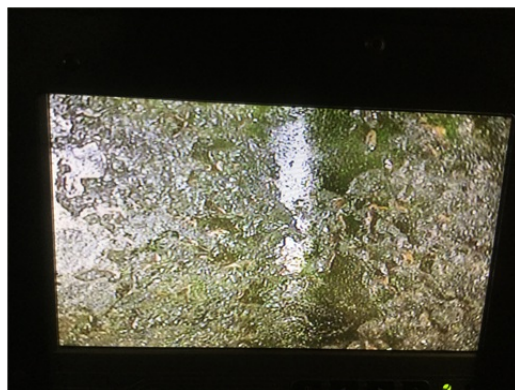
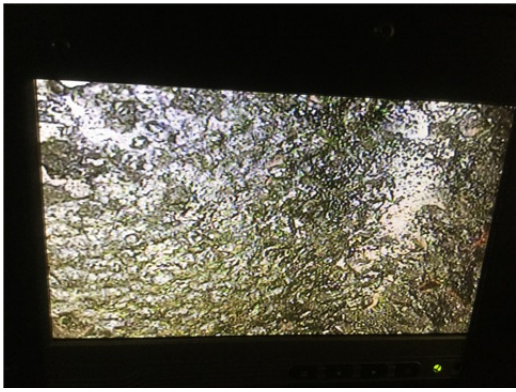
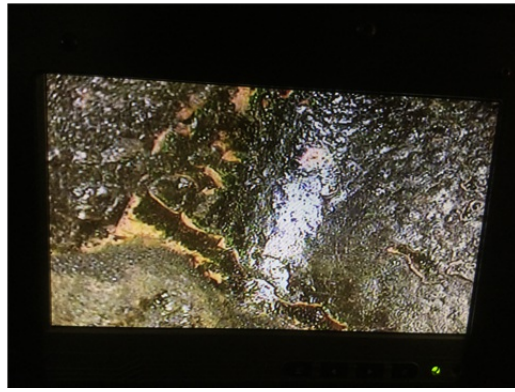
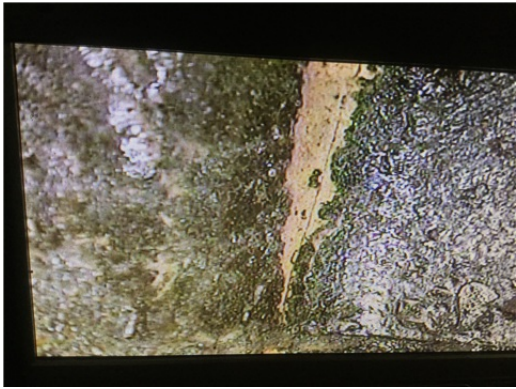
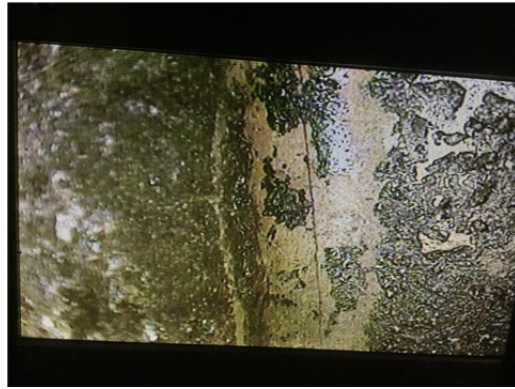
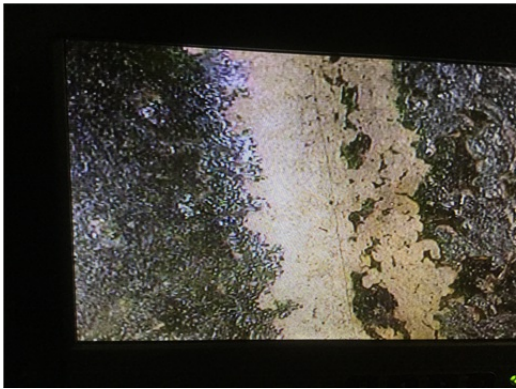
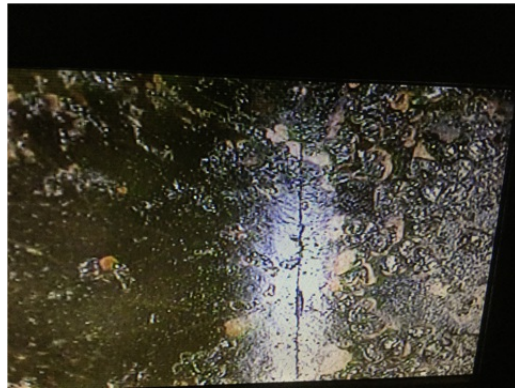
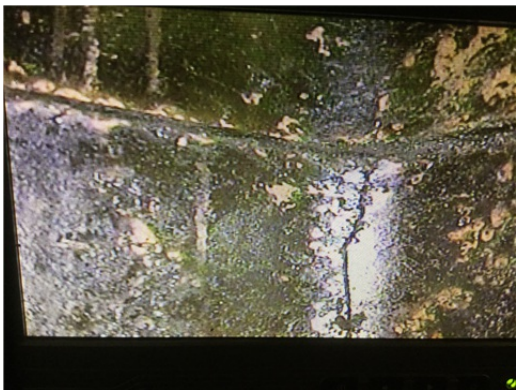
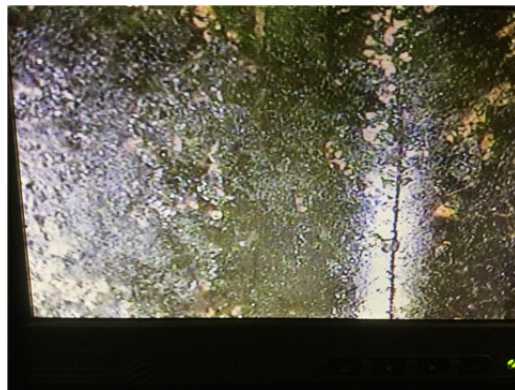
---

"All flue tiles vertically cracked due to chimney fire. Extensive glazed creosote buildup within the flue lining that will need to be chemically removed before any repairs can be made."

☒ All the tiles cracked: This was most likely caused by a sudden occurrence chimney fire. The flue lining should be replaced before use. Cracks will expand when heated and allow the combustion byproducts to escape the chimney.

- ☒ Heavily Glazed: This chimney is at high risk for a chimney fire. A creosote removal treatment should be done before use

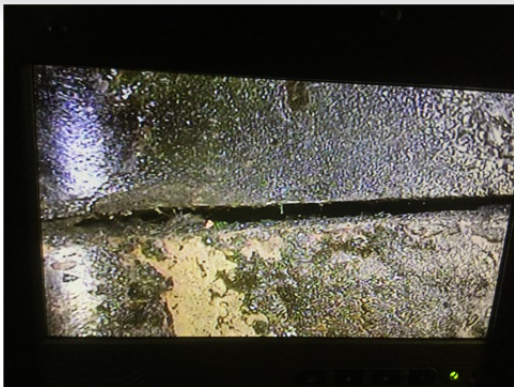
**6C**

- ☒ Missing Mortar Joints: These are supposed to be well filled with refractory cement. Missing mortar allows the combustion flue gases to escape the chimney. This will cause loss of performance in the venting system and appliance, in the form of decreased draft. Decreased draft can lead to more creosote formation in the flue lining. Often creosote will build up behind the tiles and present a fire hazard, which cannot be cleaned. (For reference see NFPA 211 7.2.10)

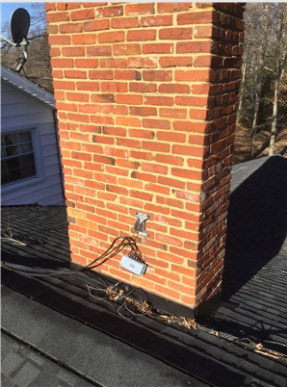
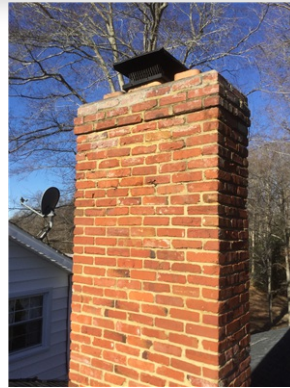
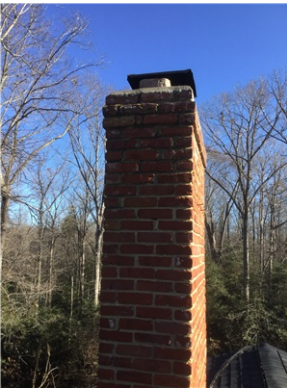
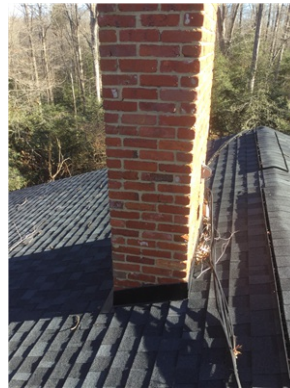
7

Roof line up of the chimney.

☒ Not 4" present: This does not meet codes and standards. When there is no divider wall between the flues this will allow for flue gases to cross over into the adjoining flue. Sometimes this will allow flue gases to come back into the home. See 2015 IRC section R1003.13 & 2016 NFPA 211 Section 7.2.14.2.

- ☒ Expansion Joint: Lack of an expansion joint has cause the flue tile to press against the crown & crack it
  - ☒ Overhanging edge: The top of the chimney does not meet Brick Institute of America standards by having at least a 1.5" overhanging edge to shed water off the chimney
-
